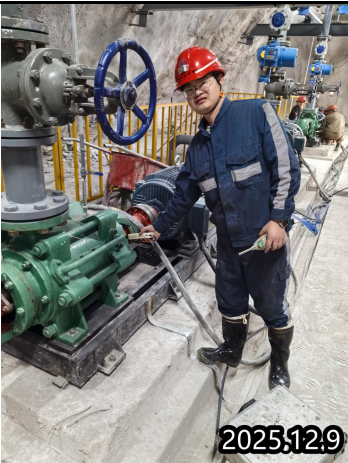
46	GX-B1500/21-2-25088	2025. 12. 11	综合判定：合格

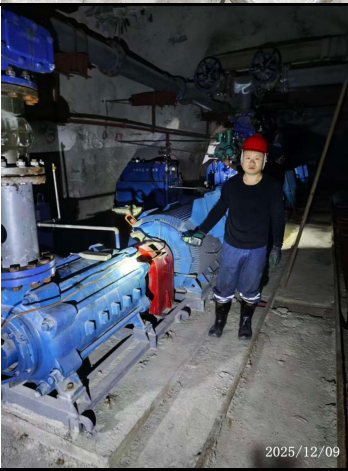
47	GX-B1499/23-2-25099	2025. 12. 11	除吨水百米电耗外， 其余所检项目合格。

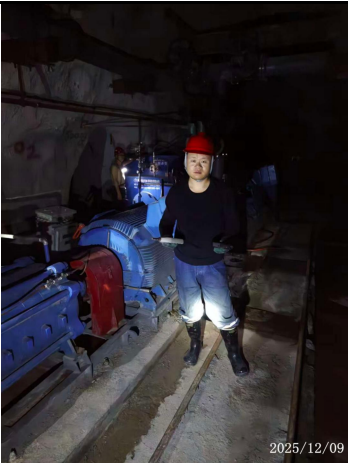
48	GX-B1499/23-2-25100	2025. 12. 11	除吨水百米电耗外， 其余所检项目合格。

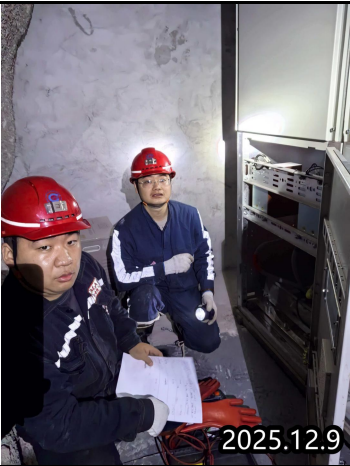
54	GX-B1329/21-2-25239~25240	2025. 12. 11	本次共检氧化锌避雷器2组，2组所检项目合格。
