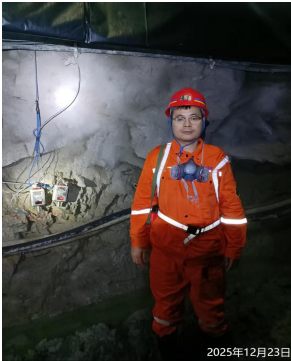
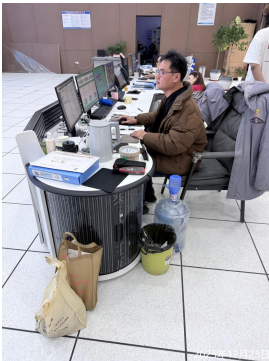
A photograph showing three workers in safety gear (hard hats, jackets) standing in front of a large, red industrial machine, likely a steam boiler or engine. The machine has a warning sign with a red and black striped pattern. The date stamp in the bottom right corner of the photo reads "2025年12月30日".
46	GX-B1371/21-9-25044	2025年12月30日	<p>存在问题： 1、监测监控设备未定期进行调校。 2、无传感器调校记录表。 建议：加强传感器日常维护及调校。 除上述问题外，其余所检项目合格。</p>
